Conventional Hydraulic Plumbing and Fitting Causes Cavitation Problem in Hydraulic System

Plastic Injection Molder

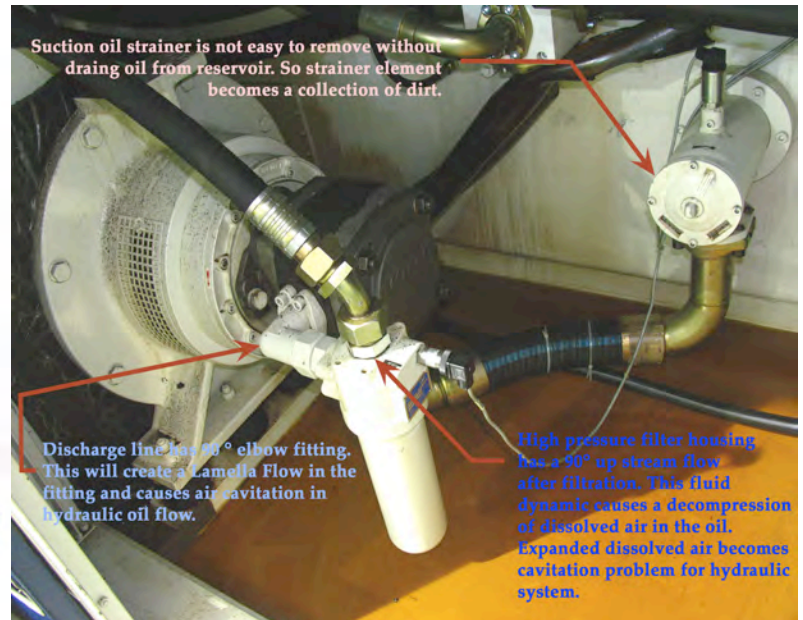
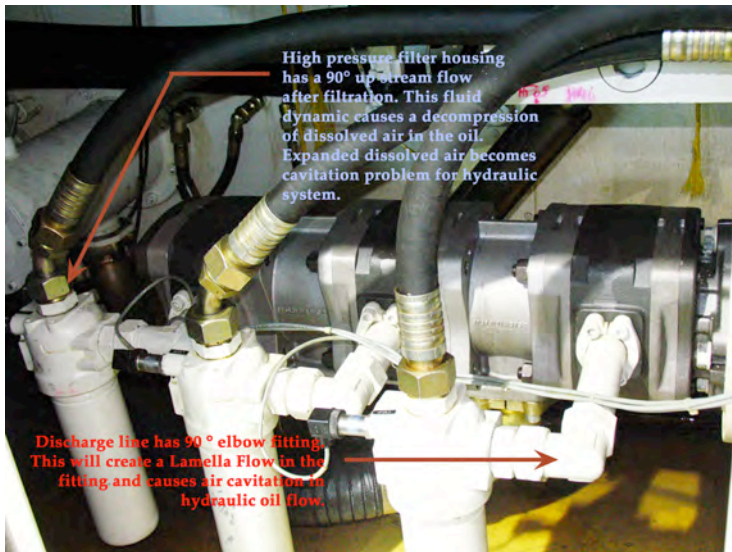
Two oil samples are obtained from the before pump suction side and after pump discharge side. There is high dirt content showing in the before suction side sample because suction strainer element is a source of high dirt collection and normally has been clean out.
