Electrostatic Charge & Oxidation and Internal Corrosion are caused by
Conventional Off-Line Filter During Oil Filtration – Hidden Operational Failure

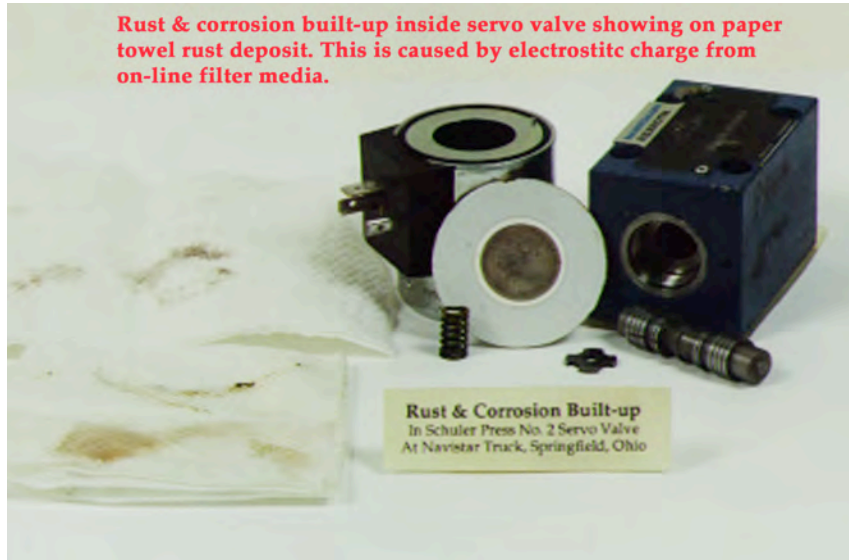
Rust & corrosion built-up inside servo valve showing on paper towel rust deposit. This is caused by electrostatic charge from on-line filter media.

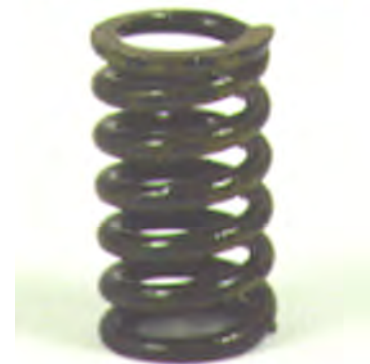
Internal spring in servo valve shows surface paint stripped out due to internal hydraulic system corrosion.

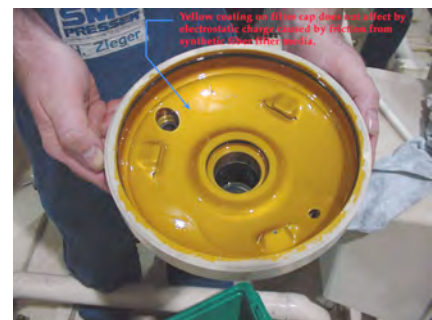
Typical hydraulic oil filter with less than 6 micron size, usually made of synthetic fiber material for better particulate retention. These **synthetic fiber materials** cause excessive friction when oil is passing through filter media. Oil carries **Free Radicals** with negative charge while metal surface of hydraulic components is acting as positive charge during the hydraulic power transmitting.

This generates **electrostatic charge** in the oil and **oxidation** reaction which leads to **internal hydraulic system corrosion**.

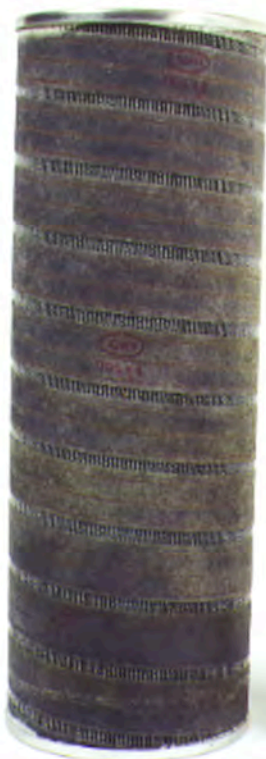
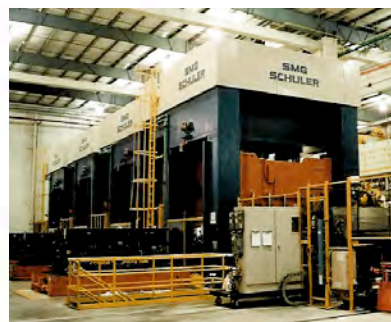
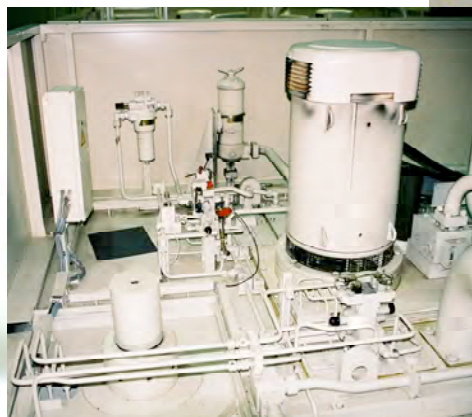
6 Micron Off Line Filter contains synthetic fiber media causing oil friction and electrostatic charge.

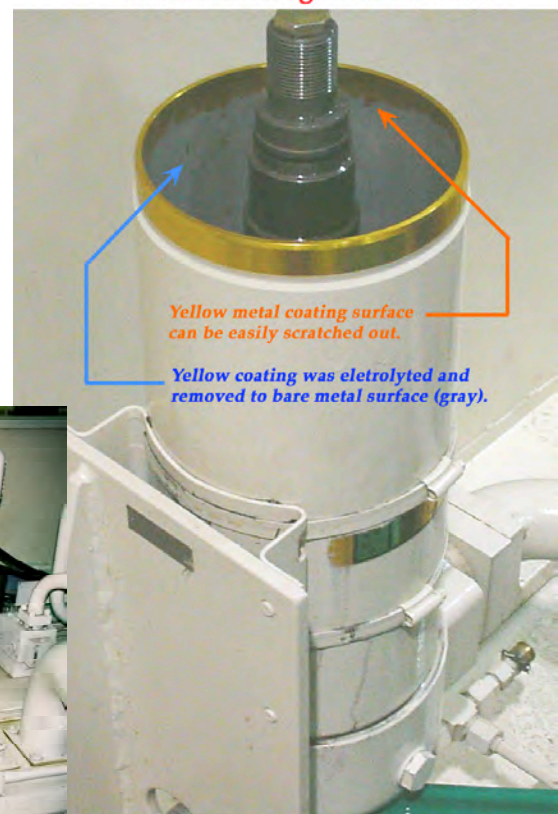
Electrostatic Charge on Filter Housing Metal Surface
