Conventional Hydraulic Plumbing and Fitting Causes Cavitation Problem in Hydraulic System

Plastic Injection Molder

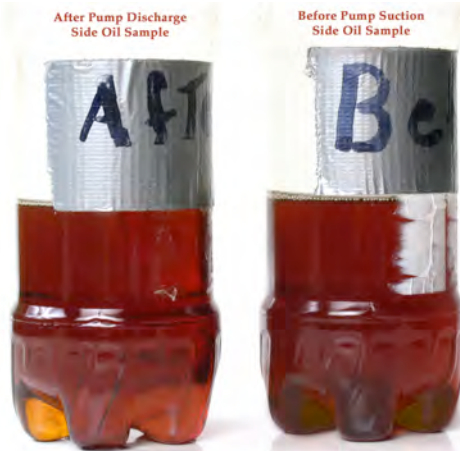
Two oil samples are obtained from the before pump suction side and after pump discharge side. There is high dirt content showing in the before suction side sample because suction strainer element is a source of high dirt collection and normally has been clean out.
